Numerical Safety and Performance Analysis of a Multipurpose Building's Structure – Case Study

This report presents a case study of a multi-use building situated in Brasília-DF. The building's structural model is made up of elements of a spatial portico and four-knot plate, measuring 25.75 by 25.75 m with a height of 11.65 m. The structure is supported by rotating pillars at the base. The ground floor has a ceiling height of 3.25 m, while the other floors have a ceiling height of 2.80 m. The closure is made of bored brick masonry. In this article, numerical analyses were conducted using the SAP2000 structural software to verify the structure's displacement, deformation, and stress. The study followed the ultimate and in-use limit state criteria for the Brazilian standard of reinforced concrete (NBR 6118). The report also presents the building's structural pathologies, detected through visual inspection. The main structural elements and their respective pathologies are described, and numerical tests are shown. Due to the presence of various cracks and other pathologies in the building, an elastic instability analysis was conducted using the Rankine-Marchant analysis model to verify

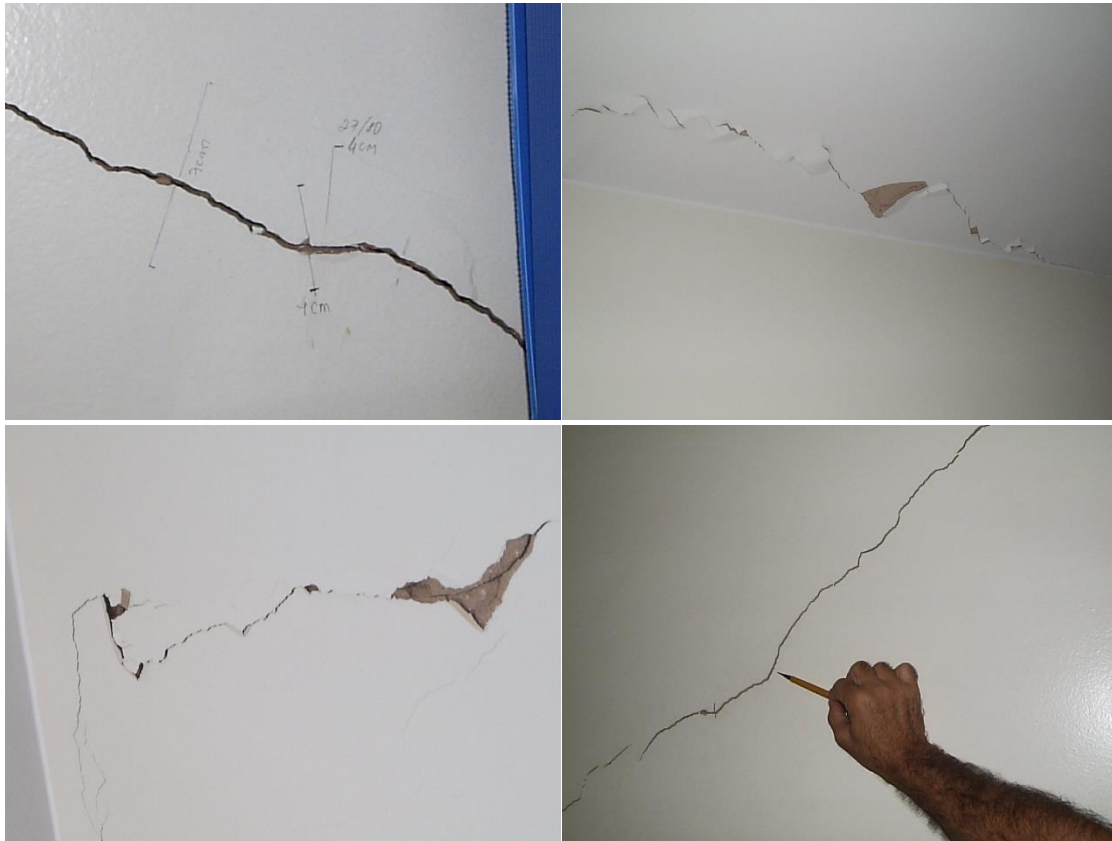
Despite encountering issues such as cracks and fissures on walls and slabs (Figure 2), the examination did not reveal any instability problems. The analysis of elastic instability indicated that the building has a stable structure, although deflections were observed above the standard limit, which contributed to the appearance of cracks in the masonry.

As per the survey, it was observed that the building and its surrounding areas were not sufficiently equipped to contain rainwater. As a result, the stormwater gallery had to be cleaned and waterproofed, which was identified as one of the primary reasons for the pathologies detected.

Figure 2 – Cracks and fissures observed in visual inspection in November 2005.

Therefore, it has been recommended that the building undergo preventive maintenance measures in order to guarantee its safety. This involved repairing the masonry and slabs, as well as addressing and treating all cracks. It is important to stress that preventative maintenance and restoration are essential not just for the safety of those utilizing the building, but also for the building's long-term resilience.
