## Architecture-Structure Conception in the Design and Performance Analysis of the CCBB Building in Brasilia

Received: 2023-09-03 | Accepted: 2023-10-05 | Published: 2023-10-11

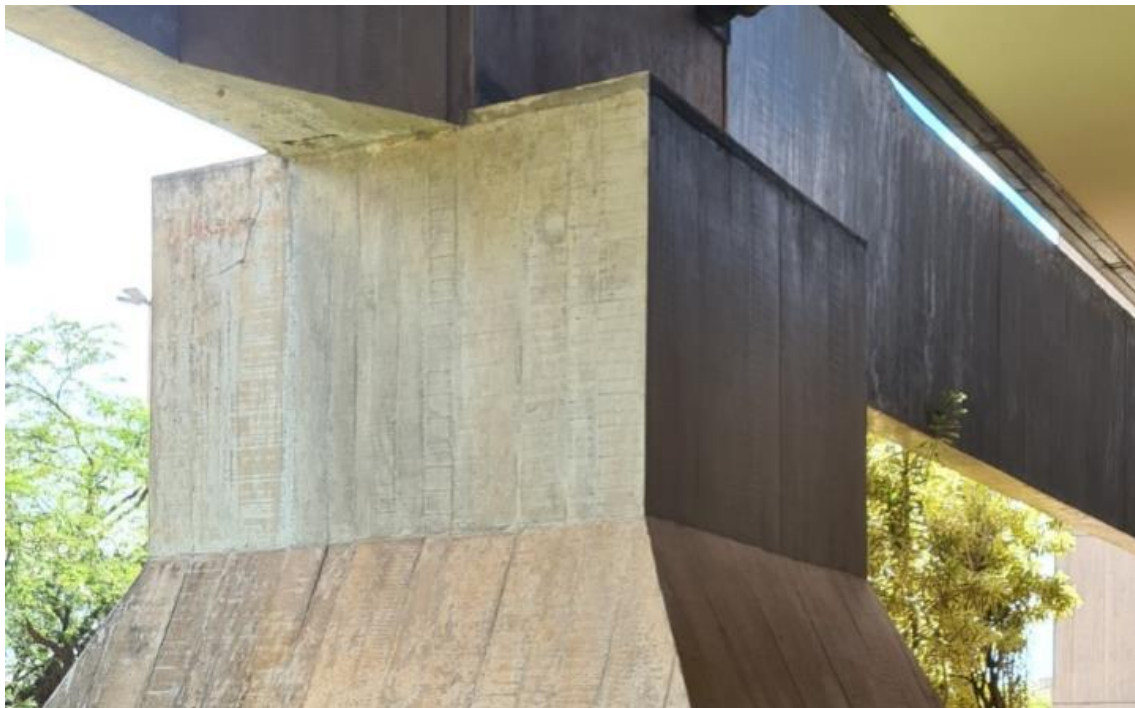
Figure 14 displays the P4A column, which has been reinforced with a concrete jacket and remains in good condition 15 years later.

**Figure 14** – Recovery and reinforcement carried out in the P4A pillar, after 15 years of execution.

In cases of concrete plate detachment, the recommended solution was to use 35MPa cement-based grout with extra reinforcement. Before applying the grout, the damaged concrete should be removed using appropriate equipment. A steel cage with vertical reinforcement was designed, forming a concrete jacket, using steel bars with dimensions that match the depth and length of the repair. The maximum coverage should be 4.0cm, and the minimum should be 2.5cm. Once the reinforcement is in place, the surface can be recomposed using concrete that matches the existing material in the structure. Figure 13 provides an illustration of the steel cage design.
