An overlooked gem in Llandaff, Cardiff: Rookwood Hospital history and heritage significance

Millena Moreira Fontes^{1*}

Received: 2023-01-03 | Accepted: 2023-02-05 | Published: 2023-02-09

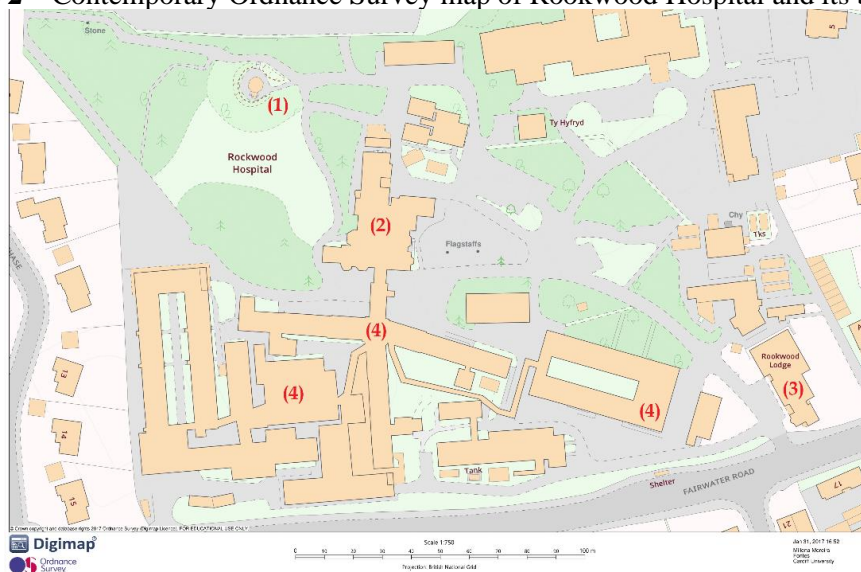
Figure 2 – Contemporary Ordnance Survey map of Rookwood Hospital and its buildings

From the 20th century onwards, Rookwood became a rehabilitation hospital (Fig. 02) arranged in a 26 acres’ site, grade II listed located in Fairwater Rd, Llandaff, Cardiff, mainly formed by a Gothic Summer House (1), a Victorian main house (2), a Lodge (3) and 8 wards (4). These constructions have a great variety of architectural styles in the same location - from the Gothic style of the 18th century, to the Victorian style from the 19th century, to wooden prefabricated buildings from the 20th century, respectively (CADW, 2003a; 2003b).

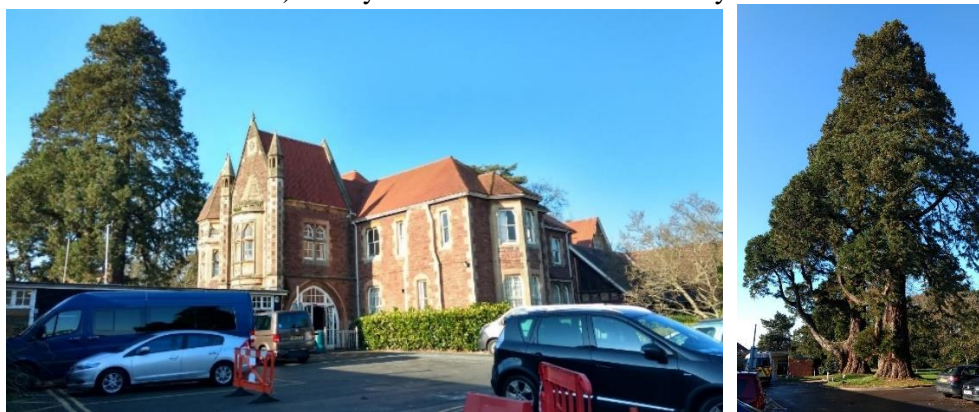
Figures 4 and 5 – Southeast view (on the left) of the Main building with the trees (right side, a zoomed view) that symbolize Sir Edward and Lady Hill’s sons.

Japanese Maples in its extensive grounds (Fig.03) (LIVING MAGAZINE CARDIFF, 2015). There are two larger trees (Figs. 04 and 05), which are a special attraction, and it is believed that it was planted to mark the birth of Sir Edward and Lady Hill’s sons.

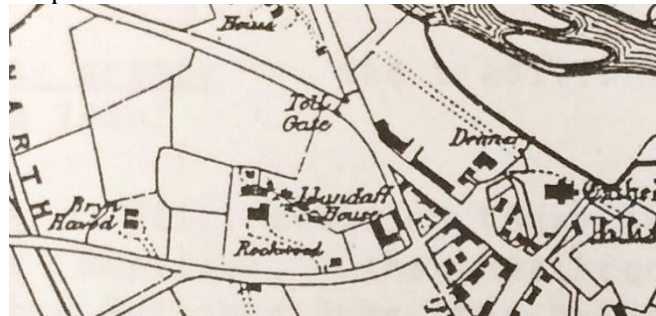
Figure 9 – Map of Llandaff from the District Plan of Cardiff & Penarth, 1869.

In the late 18th century, the land that today is Rookwood Hospital, belonged to the Estate of Thomas Edwards of Llandaff House. Figure 9 is a map from 1869, the small building above Rookwood house is the summer house, which is believed to be built in 1776 (Llandaff Society, 1995).

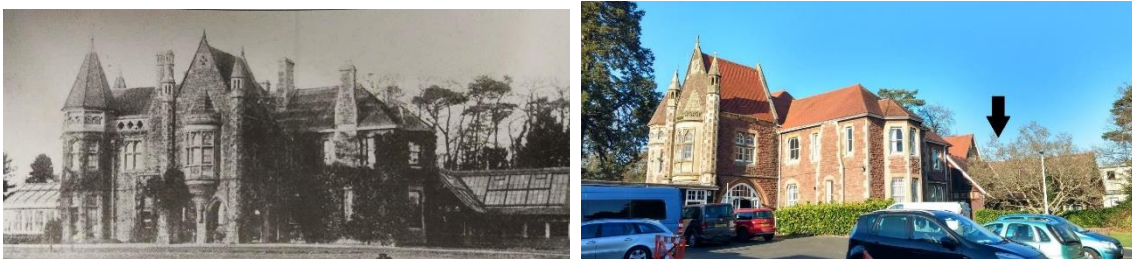
Figures 10 and 11 – On the left, Rookwood House in the 1880s. Right side, black arrow points Camellia House and Porte Cochere on the left side, now it is used as an aisle to the wards.

In the 19th century, the property was sold to Col. Sir Edward Stock Hill, who built his house in 1866. A report on (Llandaff Society, 1995, p.03) proves this fact “new houses have been erected in Llandaff within the last three years [...] One of them by my friend Edward Stock Hill, near the old Summer House where Dean *Conybeare* wrote his sermons, which with the Rookery now form part of the grounds of Rookwood House”. When built, Rookwood was a large Victorian residence (Figs.10) situated in wide meadows and surrounded by pine trees (DAVIES, 1959).

Rookwood was extended in 1881, by John Prichard, the major architect throughout the Victorian restoration and, the one responsible for the restoration of *Llandaff* Cathedral (Waldron, 1989). Extensions were a Porte Cochere, a Lodge (Fig.14, p.08) and The Camellia House, extending the eastern part of the historic structure of the main house (PETERS, 2018). Camellia house was built of teak with panels of mosaic and originally had a glazed roof (Fig. 10). Figures 12 and 13 on the next page, depict changes occurred from 1880 to 1900:

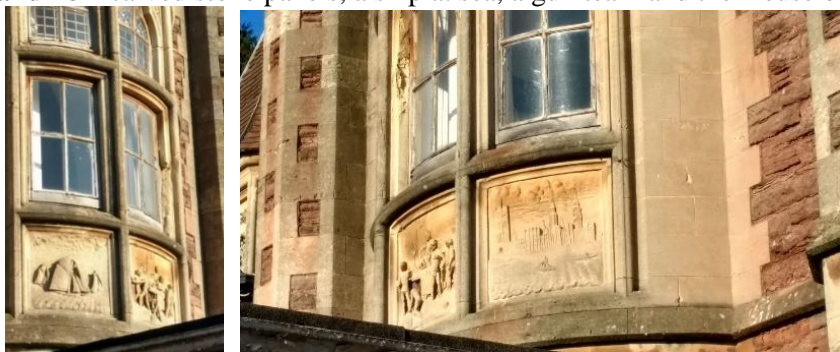
Because of this connection, one may not notice the view of three 1881's carved stone panels that relates to Sir Edward's activities (CARDIFF & VALE NHS TRUST, 2017):

Figures 17 and 18 – carved stone panels, a ship at sea, a gun team and the House of Commons.

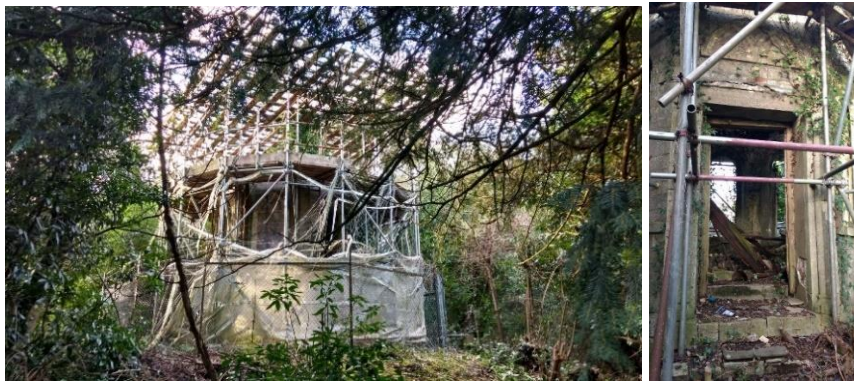
The structure is a 6.5m in height octagonal single story in Gothic style and material of external walls are Bath stone. Underneath, there is a chamber, which was believed to be an icehouse (LLANDAFF SOCIETY, 1995). The basement measures 2.4m high and, 3.2mx3m its base. The decline of the summerhouse began in the 1960s and its current state is deteriorated, the windows and door frames vanished and, there is no roof (CADW, 2003b; LLANDAFF SOCIETY, 1995):

Figures 25 and 26 – Photos from site visits showing the poor condition.

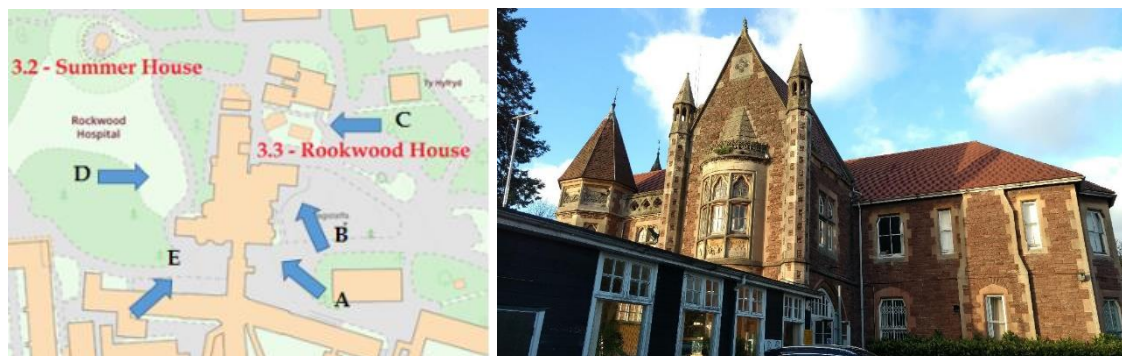
The main building is in Gothic style, a two-story house, the material of external walls is Radyr stone with Bath stone facings and red tile roofing (PETERS, 2018). The ground floor has transomed windows and typical gothic trefoil-headed windows on the first floor.

Figures 30 and 31 – Fig. 30 shows the photo views taken to describe the Main Building, on the right, View A.

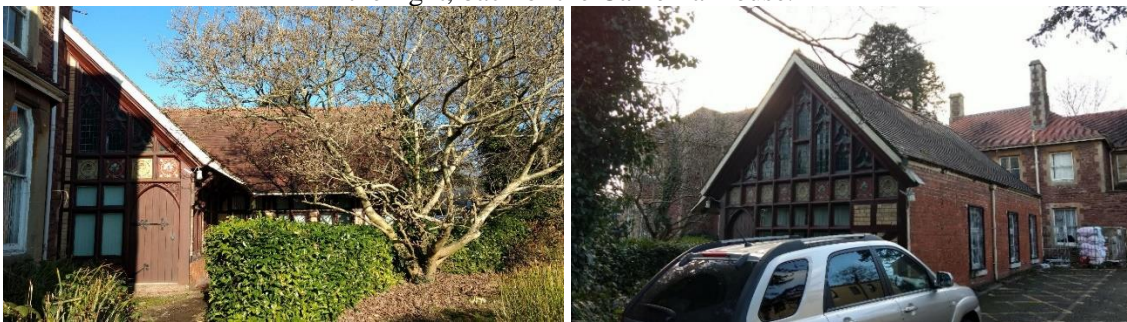
The main access is through the south-eastern corner (see letter A on the Figure above), where a projecting Porte Cochere designed by John Prichard is located (CADW, 2000). Its arches cannot be seen anymore because of the single-story modern buildings that are connecting the old house to the hospital wards. The Camellia House (Fig. 32 and 33) is located on the east front and is a single-story L-shaped half-timbered and brick building. Today, it is the Psychology Department, its façade is built with teak and has panels of flower mosaic. (CADW, 2000).

Figures 32 and 33 – The Camellia House, View B, on the left front of Camellia House and on the right, back of the Camellia House.

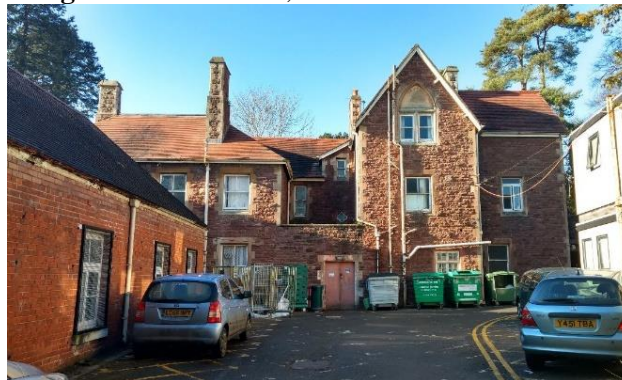
Figure 34 shows view C, it is important to draw attention to the possible decay hazards posed by the utilization of the site. For example, the garbage bins below pose significant abrasion and fire risks.

Figures 34 – View C, back of Rookwood House

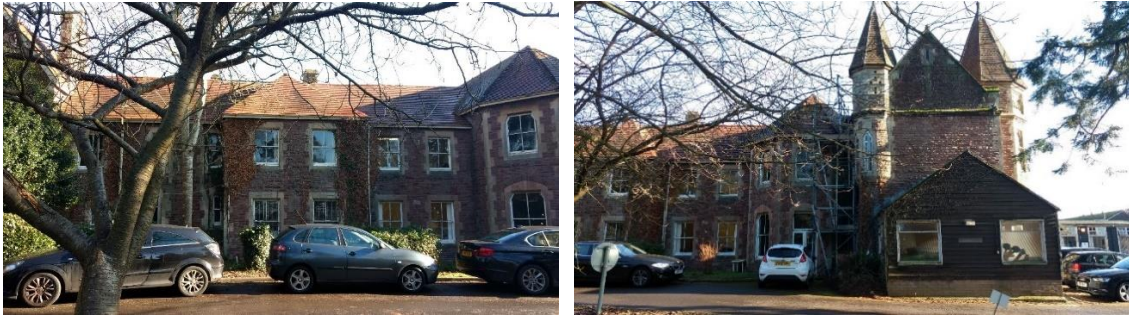
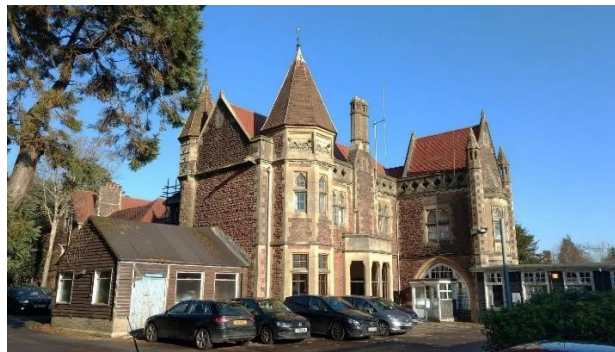
Figures 35 and 36 show view D, west part of Rookwood House, while, 37, the southwestern part:

Figures 35, 36 and 37– View D, west part of Rookwood House

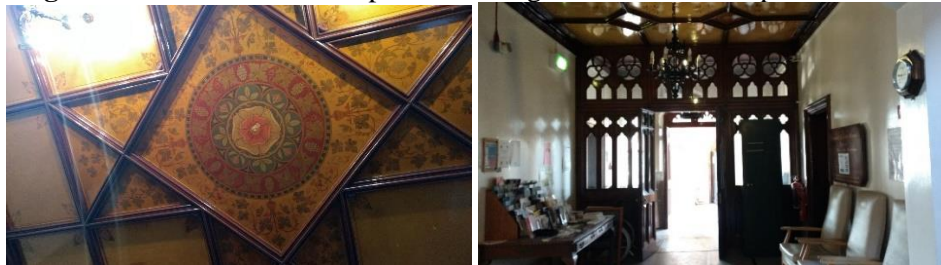
Regarding the interior of the house, internal ornaments, decorations, and painted ceilings, they were designed by J.O. Grace, artist of the Great Stair in the National Gallery. The material is polished wood of Gothic design and teak doors. Most of the interior of the house is still in good condition (CADW, 2000).

Figures 38 and 39 – Internal painted ceiling and decoration in polished wood.

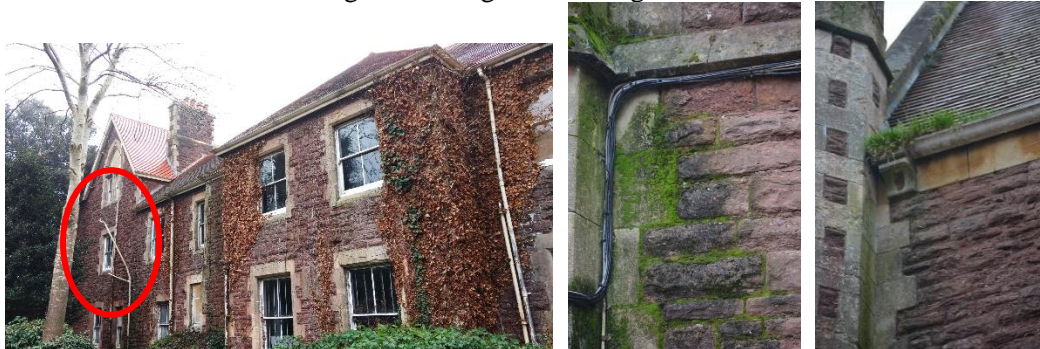
Rookwood main building is built in Radyr and Bath stone, sedimentary rock, and limestone about 160 million years old, which are commonly found in northwest of Cardiff (RCAHMW, 2000). After site visits it was noticed: poor rainwater goods, resulting in blocked gutters and growth of vegetation inside, leading moisture to leak on the walls. Old drainpipes,

slimes on walls. Also, self-clinging vegetation on walls, it roots into voids or cracks and allow water penetration.

Figures 40, 41 and 42 – Old drainpipes and self-clinging vegetation, slime on walls, and blocked gutters and growth of vegetation inside.

Stone deterioration can happen in many ways depending on the decay process, therefore investigating the type of stone is crucial when trying to find solutions and repairing it. Correctly diagnosis in a historic building requires more time and monitoring for an extensive period, up to 1 year (English Heritage, 2012). Specific expertise advice should be sought.
