Numerical Safety and Performance Analysis of a Multipurpose Building's Structure – Case Study

This report presents a case study of a multi-use building situated in Brasília-DF. The building's structural model is made up of elements of a spatial portico and four-knot plate, measuring 25.75 by 25.75 m with a height of 11.65 m. The structure is supported by rotating pillars at the base. The ground floor has a ceiling height of 3.25 m, while the other floors have a ceiling height of 2.80 m. The closure is made of bored brick masonry. In this article, numerical analyses were conducted using the SAP2000 structural software to verify the structure's displacement, deformation, and stress. The study followed the ultimate and in-use limit state criteria for the Brazilian standard of reinforced concrete (NBR 6118). The report also presents the building's structural pathologies, detected through visual inspection. The main structural elements and their respective pathologies are described, and numerical tests are shown. Due to the presence of various cracks and other pathologies in the building, an elastic instability analysis was conducted using the Rankine-Marchant analysis model to verify

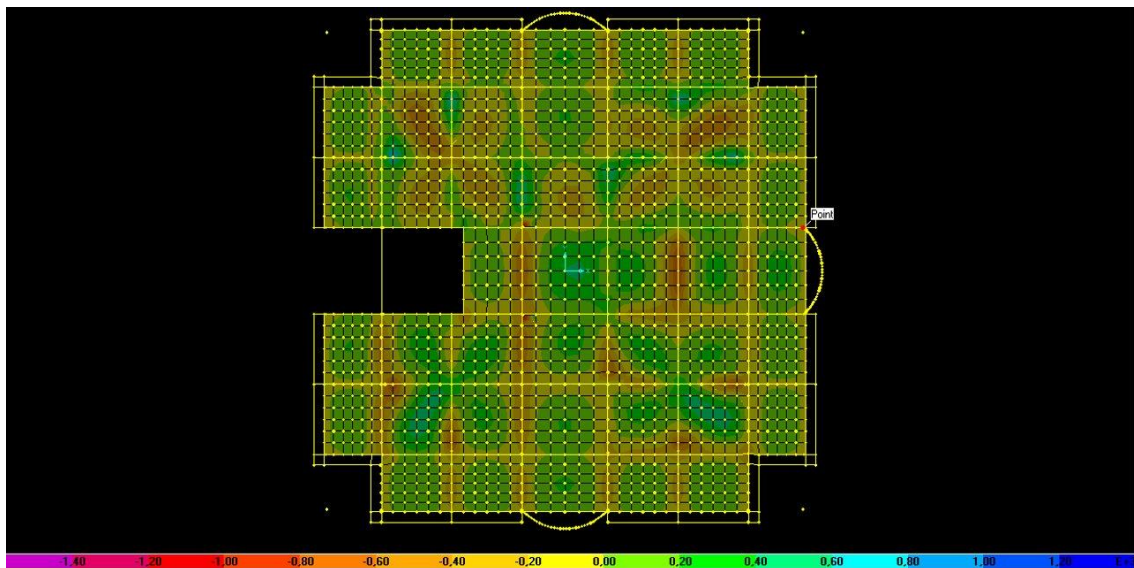
Figure 7 – Bending Moment M11 – X (Overstore)

The graphs below, Fig. 7 and Fig. 8, show moments M11 in the X direction and M22 in the Y direction of the overlay floor. These were obtained from the analysis made in 2005 using the SAP 2000 program.
